275 HIGHSTED ROAD SUBDIVISION GEOTECHNICAL FINALISATION REPORT

Reference Number: 6096

Date: 29 July 2025

275 Highsted Road Subdivision

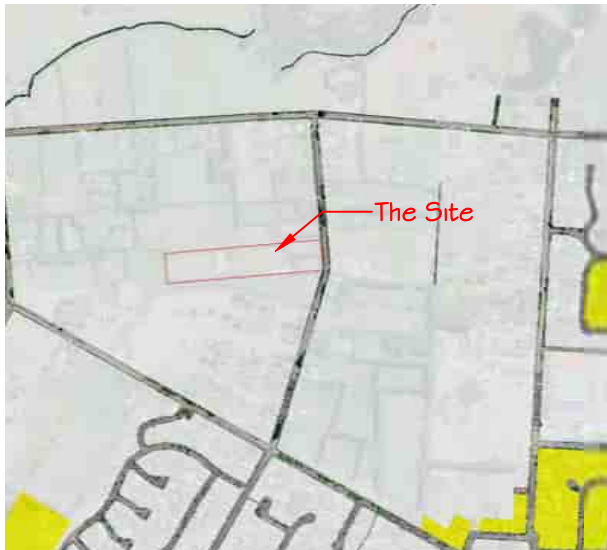
Liquefaction from Aerial Photos Feb 2011

- Moderate-Severe Observed Liquefaction
- Minor Observed Liquefaction
- No Observed Liquefaction

moderate cumulative ground deformations (100 – 200mm) at the site from the events spanning from September 2010 to June 2011 (whereas a standard analysis shows in excess of 300mm would be expected). This indicates that standard liquefaction analysis methods are likely to be over-conservative for this site. Appendix 1 (figure SK2) shows the results of these damage observations.
